Manhole Inspection Summary

Manhole # S23M1_005MH

Insp Date: **1/21/09 12:29 PM**

Location Address: **2001 W. Patapsco**

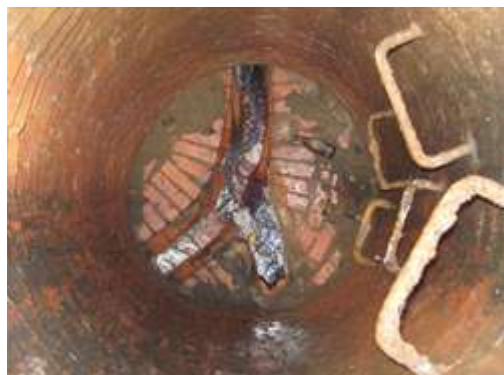
Top View

minor sediment on bench

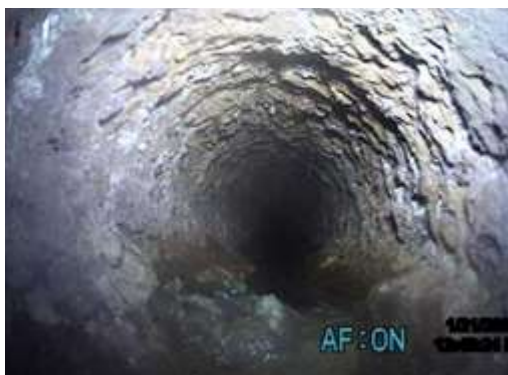
Miscellaneous

pipe deterioration @ 7 O'clock connection

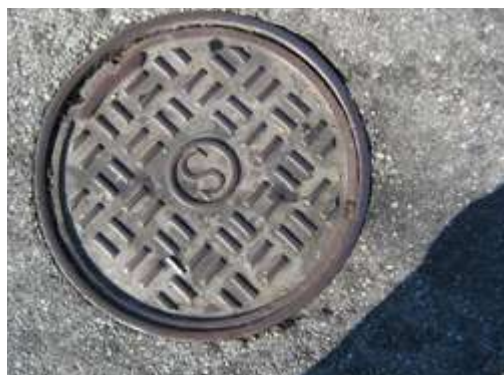
mh cover

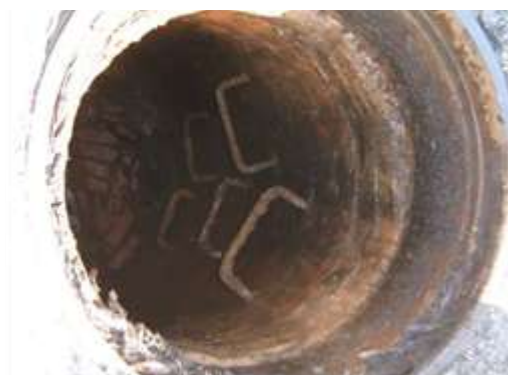
Defect 2

Offset: **0.5** (in.)

Condition: ☐ Sound ☐ Cracked ☒ **Leaks**

infiltration from top, frame offset

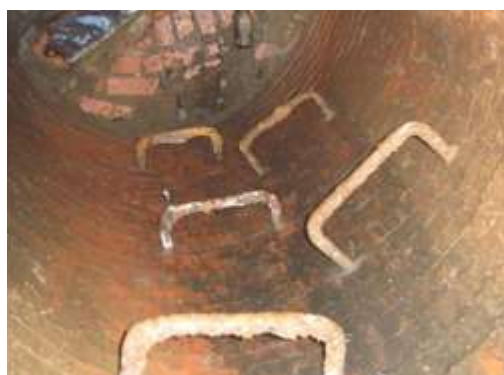
Defect 1

Infiltration: ☐ None ☒ **Joint** ☐ Cracks ☐ Mortar ☐ Roots ☒ **Wall**

Count: **5** Missing: **0** ☒ **Corroded**

infiltration from chimney to barrel,
corroded steps

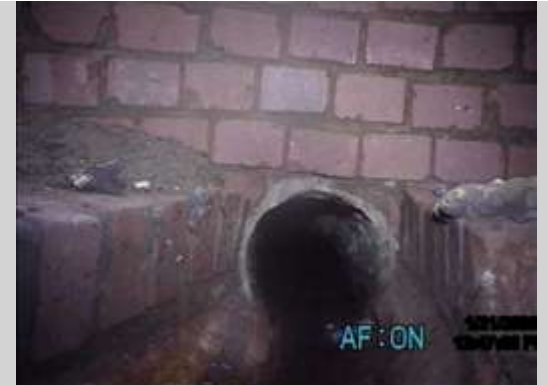
12 O'Clock Outflow

Pipe Height: **8.4** (in.) Rod and Bar (Angled)
Pipe Material: **Clay** ☐ Pipe Lined
Invert Depth: **9.51** (ft.) Flow Characteristics: **Fast**
Deposits: ☒ None ☐ Mud ☐ Sludge ☐ Debris ☐ Grease
Silt Depth: **0** (in.) Deposits Extent:
Infiltration: **None** Pipe Seal Cond: **Sound**

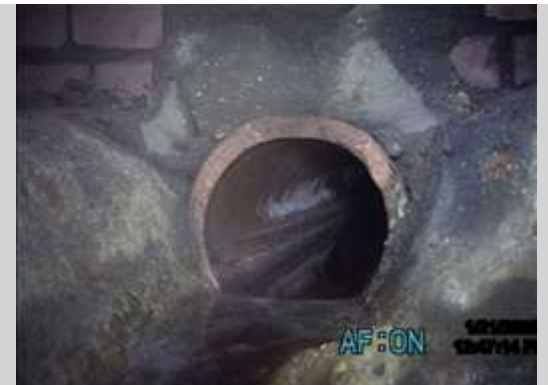
5 O'Clock Inflow

Pipe Height: **6** (in.) Rod and Bar (Angled)
Pipe Material: **Clay** ☐ Pipe Lined
Invert Depth: **9.00** (ft.) Flow Characteristics: **Fast**
Deposits: ☒ None ☐ Mud ☐ Sludge ☐ Debris ☐ Grease
Silt Depth: **0** (in.) Deposits Extent:
Infiltration: **None** Pipe Seal Cond: **Sound**

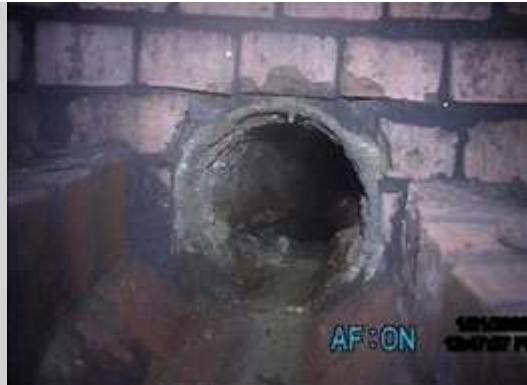
7 O'Clock Inflow

Pipe Height: **8.4** (in.) Rod and Bar (Angled)

Invert Depth: **9.05** (ft.) Flow Characteristics: **Slow**

Pipe Seal Cond: **Sound**
